Home Remodel: Built Roughly in the 1950's this Phoenix Historical Home had tile installed throughout. The customer was looking for a mottled stained look. To begin, all the tile was removed, however, there was still quite a residue.

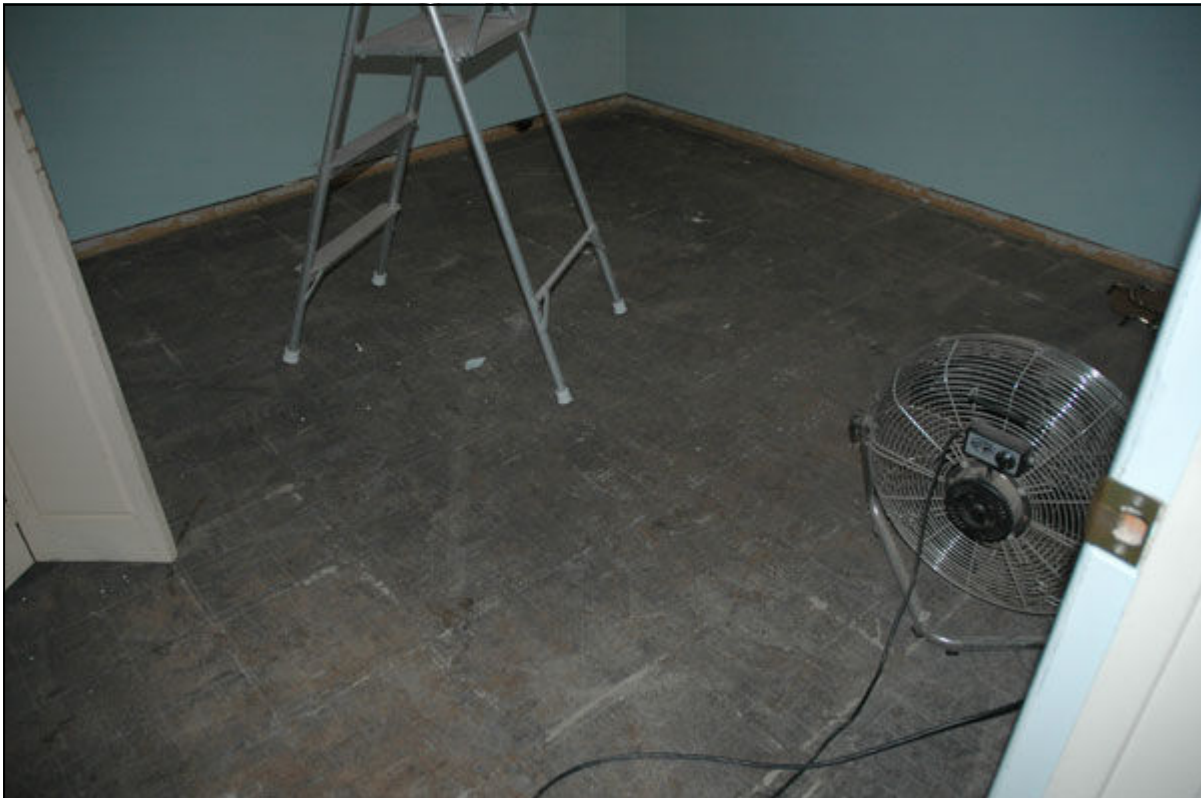
Heavy Mastic on the floor under the tile in the extra bedroom

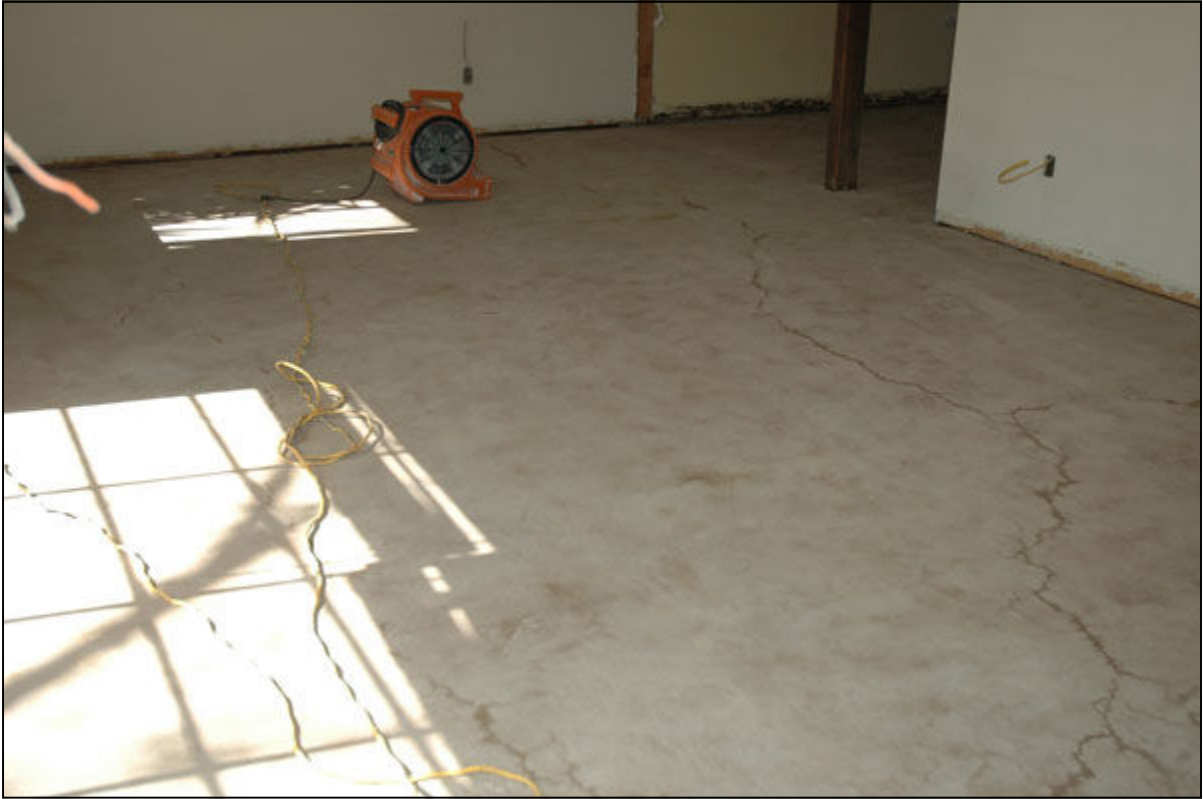
This is the main room after the removal of all the mastic. As you can see there are still cracks, but they will become part of the eco-stained look.

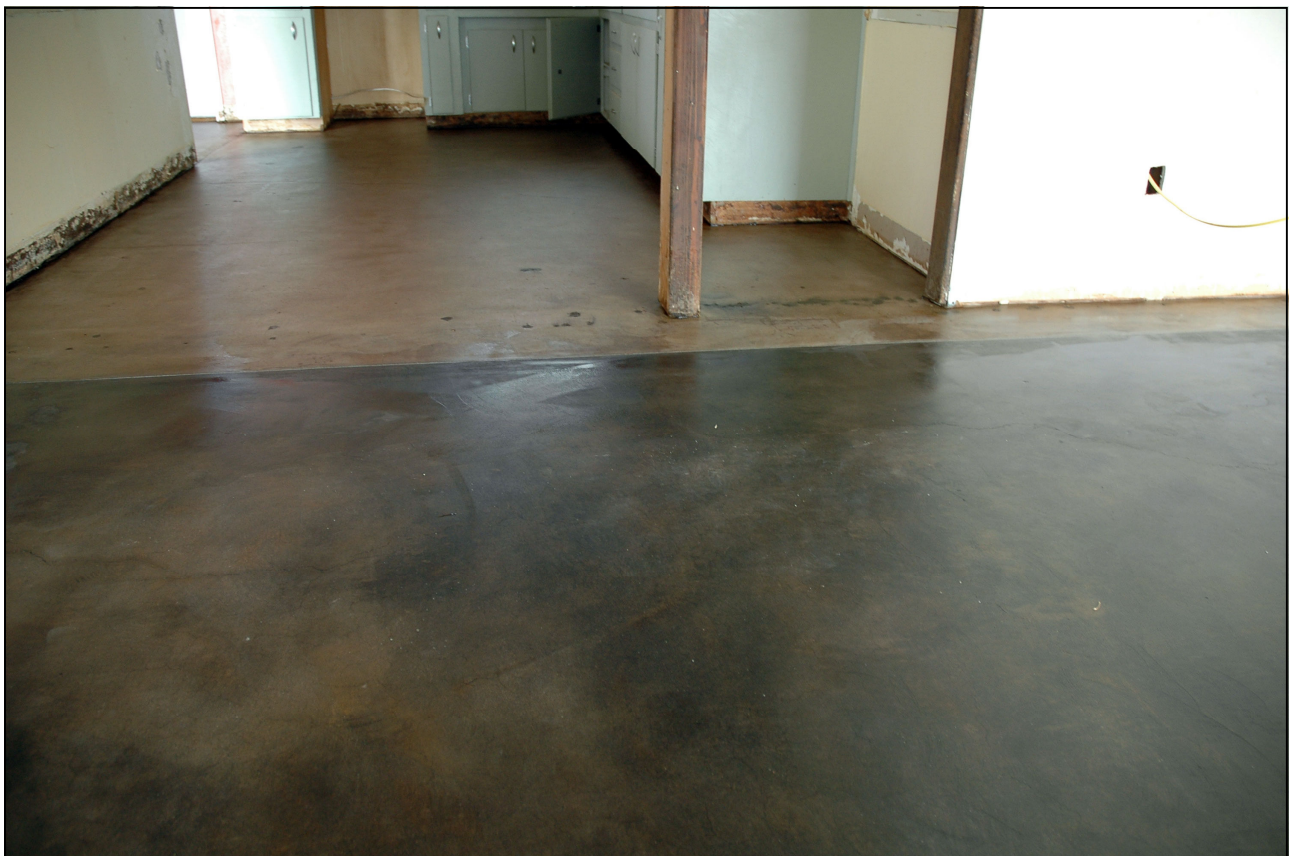
This is the main room with the final stain and seal. Notice the saw cut that separate the two colors.

The darker color is Granite Black and the lighter color is Charcoal Black. As you can tell these colors have a bit of a brown tint, this happened because the base concrete was already colored. Stains will effect concrete differently, if the concrete is colored, if it has a higher concentrate of limestone, the age and the porosity can all be factors in how the color takes.
